## **The Continuing Saga of ex-Boston & Maine Coach No. 1246 (Part V)**

*by David Woodbury*

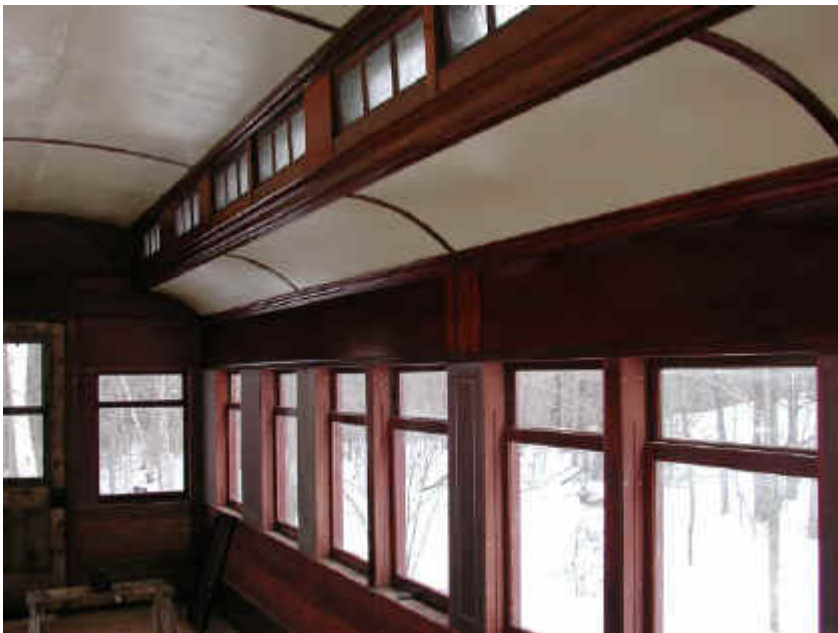
*You can begin to see the luster of the mahogany come out as the varnish is applied. Contrast the unvarnished wood. David Woodbury photo.*

As the weather cooled off, it became time to think about varnishing. I decided to go with "real" varnish rather than polyurethane even though it would dry more slowly and might be harder to apply. A few years ago, I put up a board half polyurethaned and half spar varnished and let the elements go to work on it. There was degradation on both halves with neither side being clearly better than the other. For the inside of the car, weather wouldn't be a problem, but I thought that being true to the original in this case made sense and acted accordingly. The varnish I chose was an interior varnish, not spar, and it worked well. The process over mahogany is slow. A dressing with paste filler and the attendant clean up followed by a thinned down coat of varnish and two full coats rubbed out with rottenstone makes for a lot of time spent on a small area. I was able to do the upper deck, as Pullman calls the clerestory window area, but that was about all before the early cold weather put a stop to those activities.

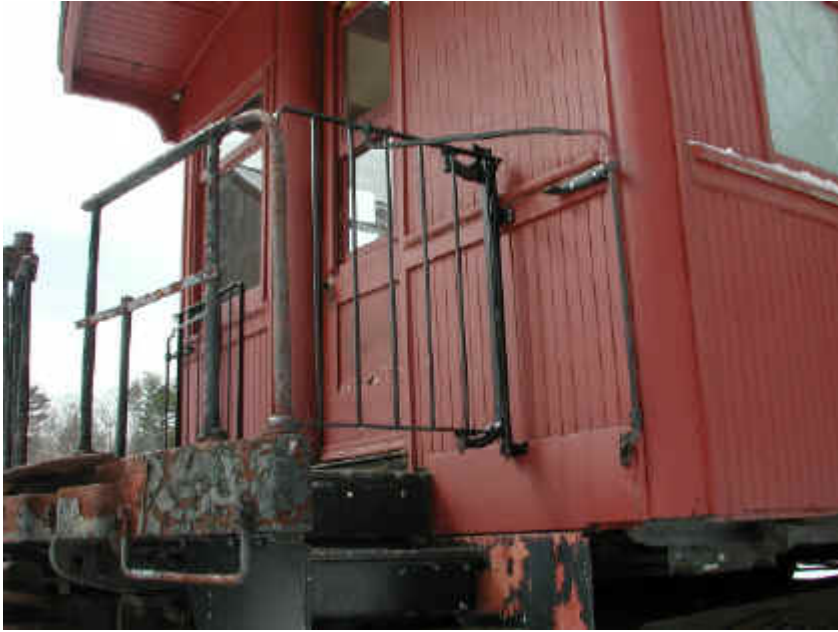
*The Woods Safety Gate may have been state of the art a century ago. Looks like plenty of room to topple over or slip under.  
David Woodbury photo.*

The weather wasn't so cold as to preclude all work so I turned my attention to the Woods Safety Gates that had lain unattended in my barn and basement for years. These gates both swing and fold so as to block the steps from the platform and thereby make crossing between cars safer. This cannot have been easy under the best of conditions considering the complete lack of an enclosing vestibule. Passengers would have had to walk directly on the buffers with only light chains protecting them from falling between the cars. The safety gates wouldn't have prevented that kind of accident, but would have (maybe) prevented falling down the steps. The gates are

When I got the car, it came with 2 1/2 sets of these gates. Luckily, there was at least one of each piece so I didn't have to wonder what some of them looked like. I was fortunate in finding a pattern maker who replacement castings made for me, but I had to make the fourth actual gate and the hand grips out of available flat and round stock. By the time the weather really closed in, I had three of the four gates installed.

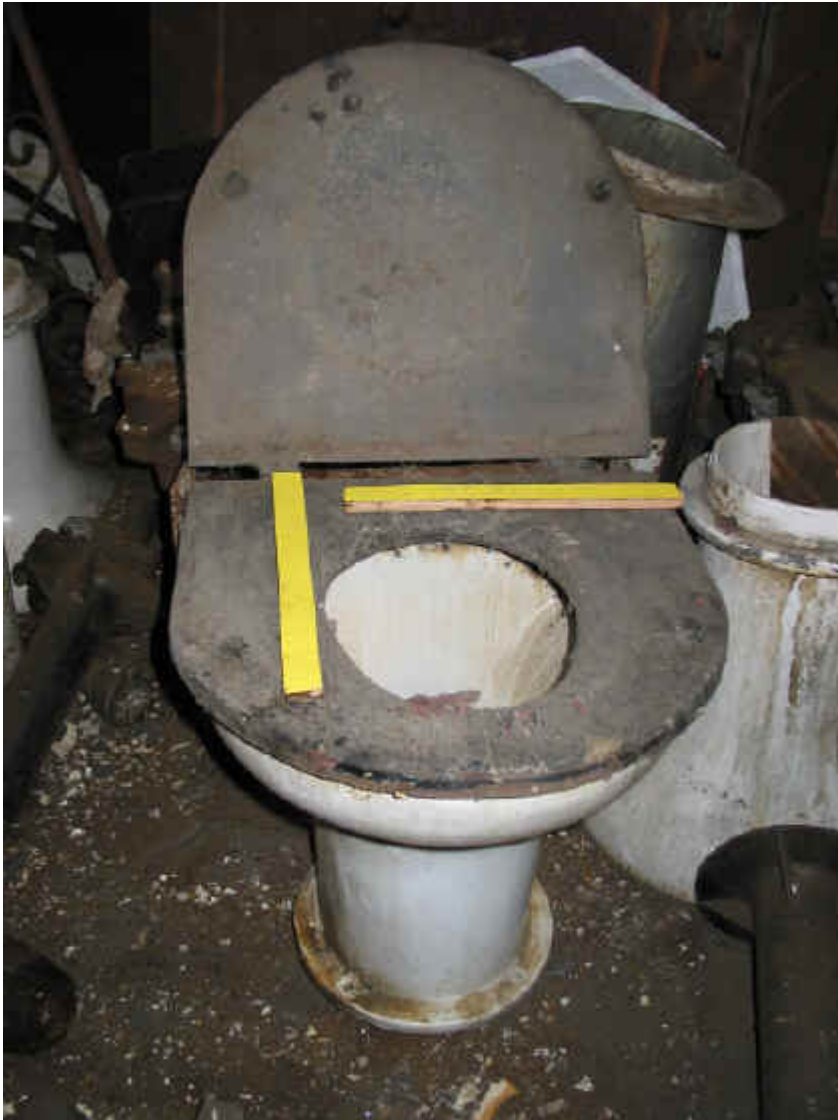
*A pot of gold at the end of the rainbow? Maybe not, but a pot just the same. The yellow sticks were placed to show scale. Nelson Saxe photo.*

I knew from the amount and kind of stuff that had been in my car, that Steamtown had squirreled away things that they might have wanted in the future and so responded. A few others did as well, but not as many as might have. His description of what he thought he had was mildly encouraging and I suggested pictures which he eventually sent after making up a compact disc. On reviewing the pictures, I realized that he had a number of dry hoppers, which he at first thought were sink stands until he turned one over and saw the toilet seat. Since these were undoubtedly of B&M origin and, being totally flushless, of a much earlier era than the usual heavyweight equipment, I knew to virtual certainty that these had come out of the fleet of B&M wooden coaches bought by Nelson Blount in the late fifties.

There's nothing like a winter road trip to lift the spirits so off I went to eastern Pennsylvania, bought the toilets and came home, all in two days. In a kind of baker's dozen type of a deal, I got four and had a metal one thrown in free. The **Illinois Railway Museum** has expressed an interest in the remaining two china hoppers for their B&M diner, but the metal hopper (caboose style?) is looking for a home.
